**Usage of Multi-Axis Fiber Grating Strain Sensors  
to Support Nondestructive Evaluation of Composite Parts  
and Adhesive Bond Lines**

**Eric Udd, Steve Kreger, Sean Calvert, Marley Kunzler, and Katy Davol**

The 4<sup>th</sup> International Workshop on  
Structural Health Monitoring  
Stanford University

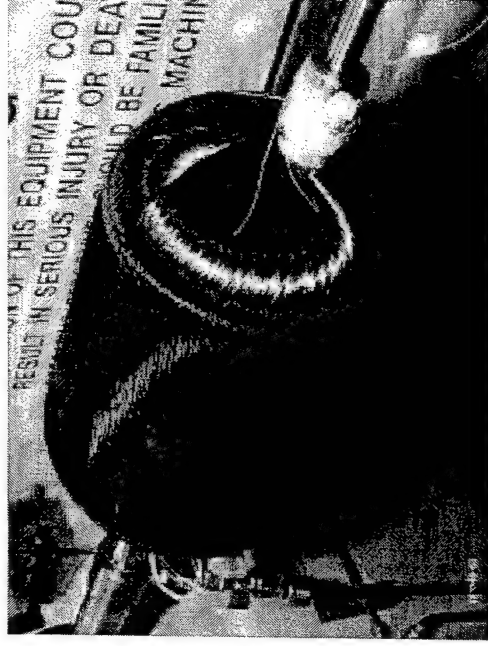
# Casing with Embedded Fiber Grating Strain Sensors
